Manhole Inspection Summary

Manhole # S55C__004MH

Insp Date: **6/23/08 8:25 AM**

Location Address: **3533 e fayette st**

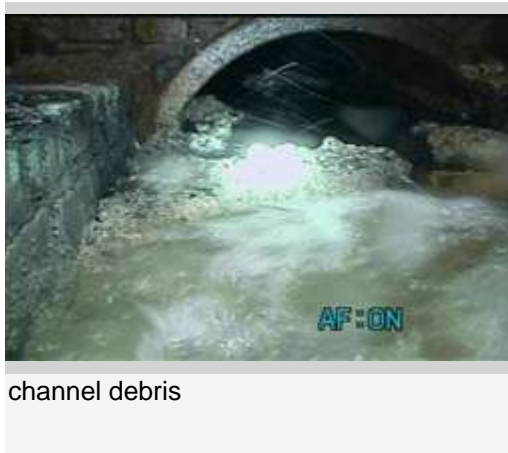
Defect 6

Condition: ☐ Sound ☐ Cracked ☐ Root Intrusion ☐ Deteriorated ☐ Leaks ☒ **Debris**

channel debris

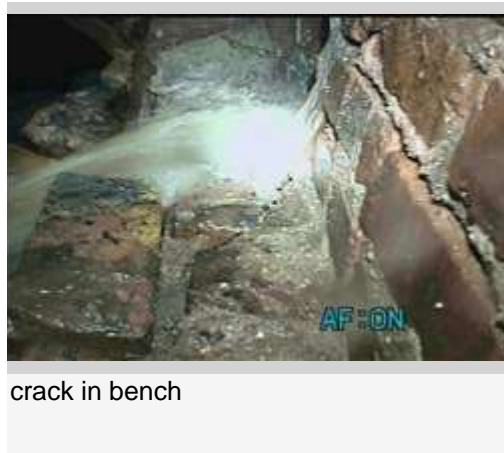
Defect 5

Condition: ☐ Sound ☒ **Cracked** ☐ Root Intrusion ☐ Deteriorated ☐ Leaks ☐ Debris

crack in bench

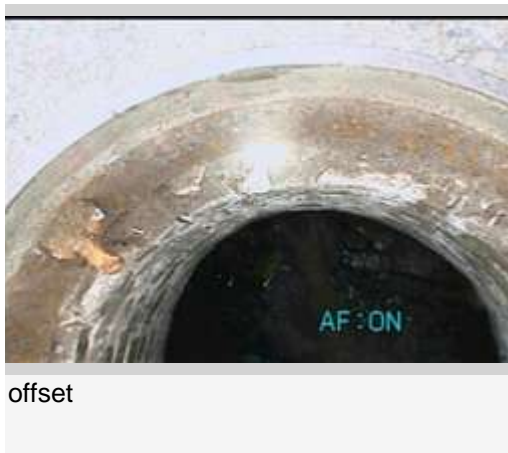
Defect 4

Offset: **2** (in.)

offset

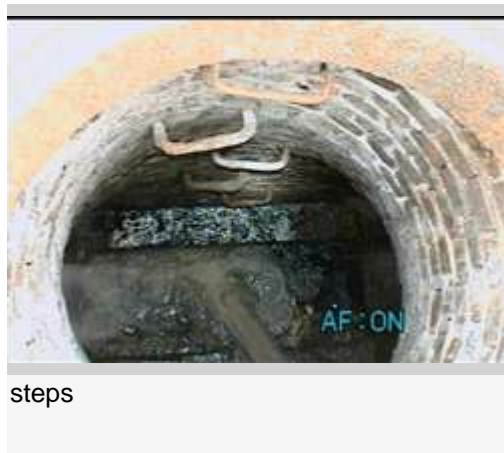
Defect 3

Count: **5** Missing: **0** ☒ **Corroded**

steps

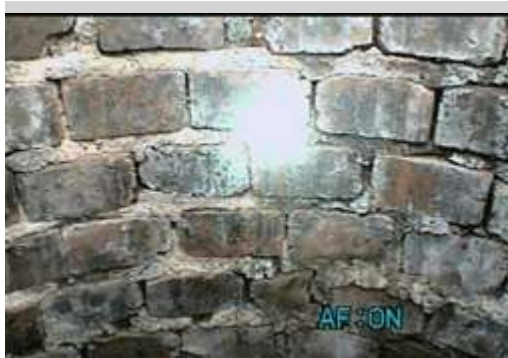
Defect 2

Condition: ☐ Sound ☐ Cracked ☐ Root Intrusion ☒ **Loose Brick** ☐ Deteriorated

corbel condition loose bricks,

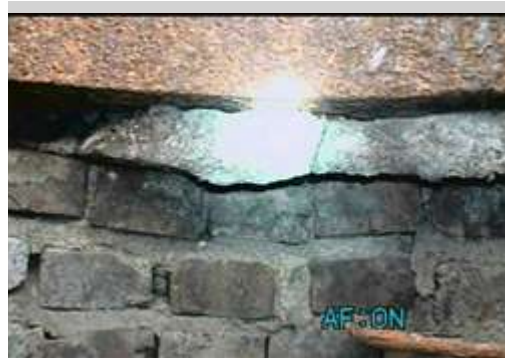
Defect 1

Condition: ☐ Sound ☒ **Cracked** ☐ Root Intrusion ☒ **Loose Brick** ☐ Deteriorated

chimney loose bricks, cracked, FRAME
ADJ

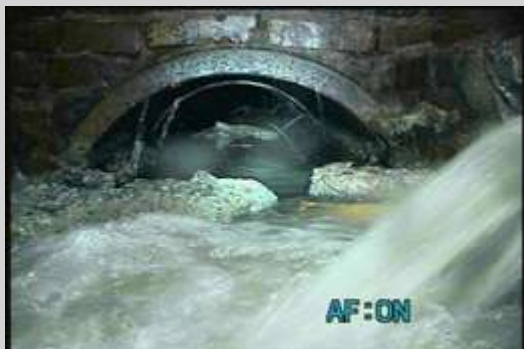
6 O'Clock Inflow

12 in. Circular Gravity Sewer
Pipe In @ 6 O'Clock

Deposits: ☐ None ☐ Mud ☐ Sludge ☒ **Debris** ☐ Grease

Silt Depth: 8 (in.) Deposits Extent: **Heavy**
